Maine Municipal Association
RISK MANAGEMENT SERVICES

Re: Property Safety Survey (MR)
Town Hall

Report Name: Property Safety Survey (MR)
Completed for: Town of Sangerville
Inspection Date: June 13, 2022
Location: Town Hall
Contact: Lorna Bell, Town Manager

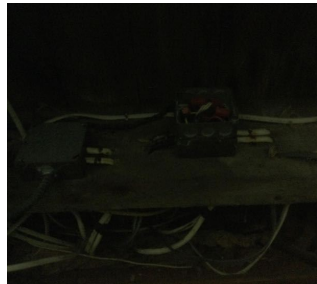
Basement near stairs and
sprinkler riser

Issue Identified **Live parts of electrical equipment were not adequately protected against accidental contact (1910.303)**

Notes: Multiple exposed electrical boxes in the basement. Recommend any live electrical is installed to manufacture specifications.

Recommendation *Have a qualified electrician make repairs to electrical equipment and/or install tight fitting covers to protect workers against accidental contact with live parts of electric equipment [reference 1910.303(g)(2)(i)]. [View OSHA Standard](#)*

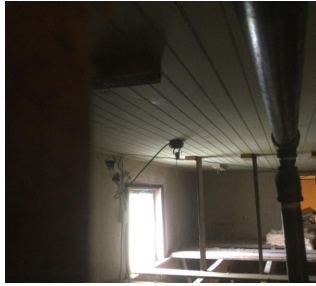
Under stage near back wall

Issue Identified **Live parts of electrical equipment were not adequately protected against accidental contact (1910.303)**

Notes: Under stage hanging light fixture suspended by wiring. Recommend any live electrical is installed to manufacture specifications.

Recommendation *Have a qualified electrician make repairs to electrical equipment and/or install tight fitting covers to protect workers against accidental contact with live parts of electric equipment [reference 1910.303(g)(2)(i)]. [View OSHA Standard](#)*

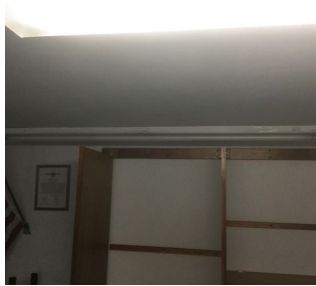
Community room

Issue Identified **Not all light bulbs/lamps are protected from accidental damage (1910.305)**

Notes: Lights over voter booths are unprotected, recommend lights is protected by sleeves or factory covers.

Recommendation *Take steps to ensure all light bulbs and/or fluorescent lamps used for general illumination are protected from accidental contact or breakage by a suitable fixture or guard. Note: plastic sleeves on fluorescent lamps are an acceptable means of protection [reference 1910.305(a)(2)(ix)]. [View OSHA Standard](#)*

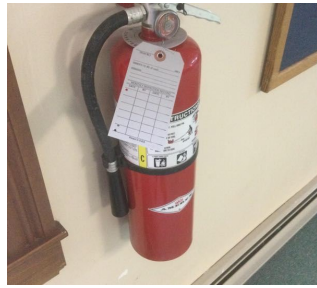
Through out City hall

Issue Identified Not all portable fire extinguishers are inspected monthly (1910.157)

Notes: Fire extinguishers need to have the monthly inspections done and documented on tags or in a inspections log.

Recommendation The employer is responsible for the inspection, maintenance and testing of all portable fire extinguishers in the workplace. Portable extinguishers shall be visually inspected (and documented) at least monthly. [reference 1910.157(e)(2)]. [View OSHA Standard](#)

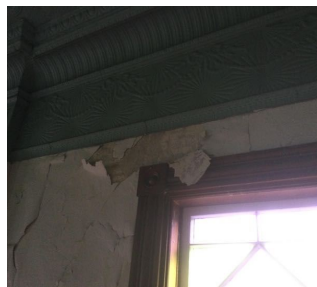
Balcony near windows

Issue Identified **Lead exposures are not monitored and/or effective measures are not in place (i.e. hand washing facilities not available, respirators not provided or used properly, wet-cleaning methods not used, etc.) to maintain exposure below 50 micrograms/cubic meter over an 8-hour period (1910.1025)**

Notes: Old paint is chipped flaking and falling, recommend Lead testing is completed to ensure paint is do not contain lead.

Severity: Serious

Recommendation *Take steps to monitor lead exposure in the work area and implement engineering and/or administrative controls (i.e. hand washing, use of respirators, wet-cleaning, etc.) to limit worker exposure below 50 micrograms/cubic meter over an 8-hour period (reference 1910.1025). [View OSHA Standard](#)*

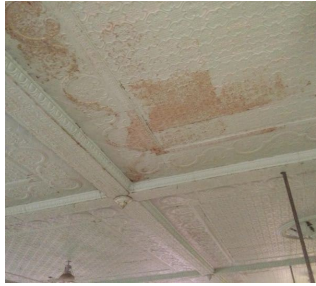
Ceiling above balcony

Notes: Tin ceiling above balconies appear to have rust/ corrosion which appears to be from water intrusion. Recommend roof is inspected for leaks and repaired, and tin ceiling is repaired/ replaced to prevent mold/ mildew and un fastened ceiling falling.

Severity: Serious

Take appropriate steps to address hazardous condition(s) that could lead to property damage. (See notes or photos for details).

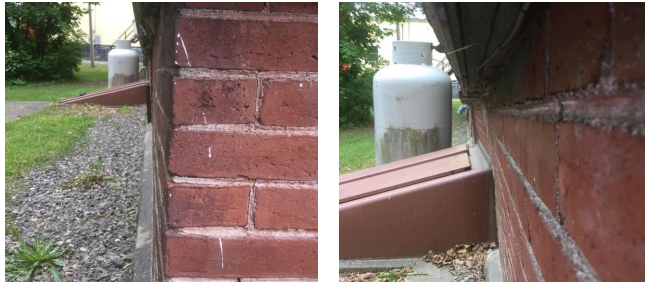
Notes: Bulkhead side wall has severe movment from top to bottom. Brick wall is bowing inward and near ground level and outward toward sill plates. Recommended a full engineering study.

Severity: Structural

Bulkhead side sweep in foundation wall. Recommend a qualified engineering company do a complete structural assessment of the building.

Recommendation *Anomalies that appear to be related to the structural integrity of the building were observed. Because of the significance of these observed anomalies we recommend you contact a professional engineer, who holds a current, active professional engineer's license in the State of Maine, to assess the structural integrity. Please notify your Loss Control Consultant when the engineer survey will be completed, and email a digital copy to them, when available for review. After Maine Municipal Association's review of the engineer's survey, additional recommendations maybe issued.*

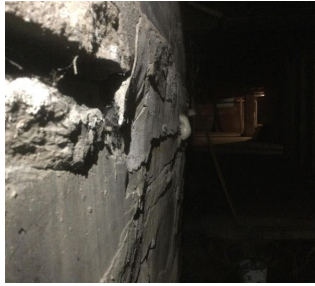
Basement wall on Parking lot side

Notes: Foundation walls appear to be bowing inward in the middle and outward toward the sill plates. Recommend a a qualified engineering company do a complete structural survey of the building.

Severity: Structural

Foundation wall on parking lot side has evident inward bow. Recommend wall is assessed by a qualified engineer and repaired accordingly.

Recommendation *Anomalies that appear to be related to the structural integrity of the building were observed. Because of the significance of these observed anomalies we recommend you contact a professional engineer, who holds a current, active professional engineer's license in the State of Maine, to assess the structural integrity. Please notify your Loss Control Consultant when the engineer survey will be completed, and email a digital copy to them, when available for review. After Maine Municipal Association's review of the engineer's survey, additional recommendations maybe issued.*

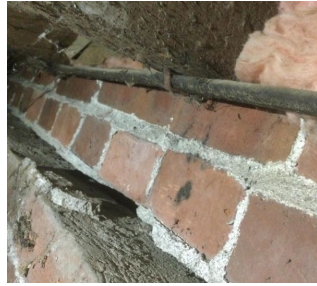
Notes: Road side foundation wall has sever separation of bricks near the top of the brick wall. Wall shift is 3/4s the width of the brick. Recommended a qualified engineering firm conducts a full structural assessment of the building and all repairs are completed with engineer approval.

Severity: Structural

Brick separation on road side.

Recommendation: to Have a qualified Engineer to a complete structural assessment of the building from the basement to the roof.

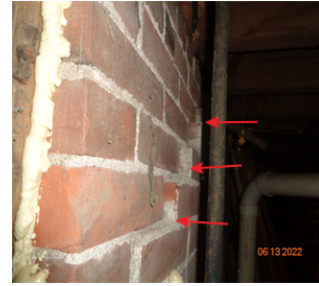
Step crack with horizontal separation of bricks on road side. Recommend a qualified engineering firm conducts a full structural assessment.

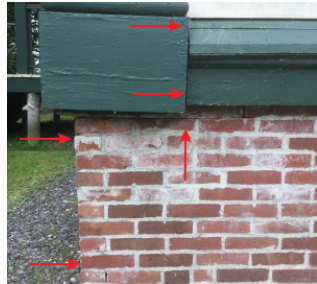
Evident wall movement on roadside/ parking lot corner.

Road side exterior, wall has inward bow from granite up to part way up brick. Top of brick wall is leaning outward.

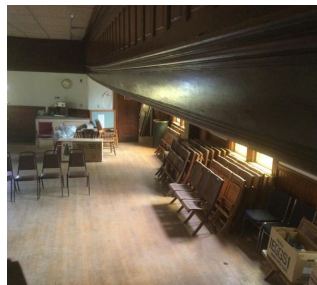
elevated balconies

Notes: Balconies appear to have a sag in the middle across the entire span. Recommend structural components are evaluated by a qualified engineer.
Severity: Structural

Recommendation *Minor structural damage or anomalies were noted during the survey. Have a qualified contractor review and make the necessary repairs. Contact your Loss Control Consultant and provide a photo when hazard has been corrected.*

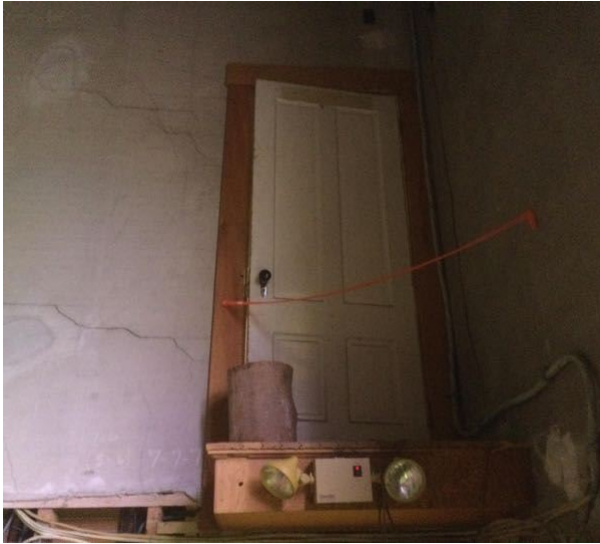
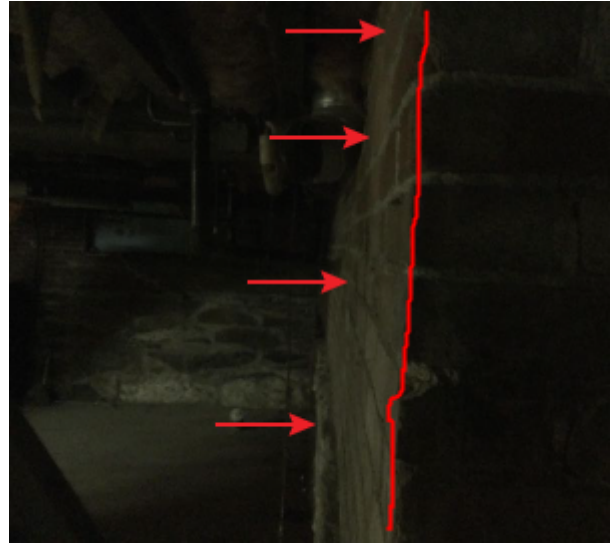
At bulkhead looking toward road, wall has evident movement. Recommend an engineer provide a structural assessment of the building and repaired.
