DIRIGO ENGINEERING

May 6, 2024

#61101

Mr. Jeff Libby, Town Manager
Town of Sangerville, Maine
93 Main Street
PO Box 188
Sangerville, ME 04479

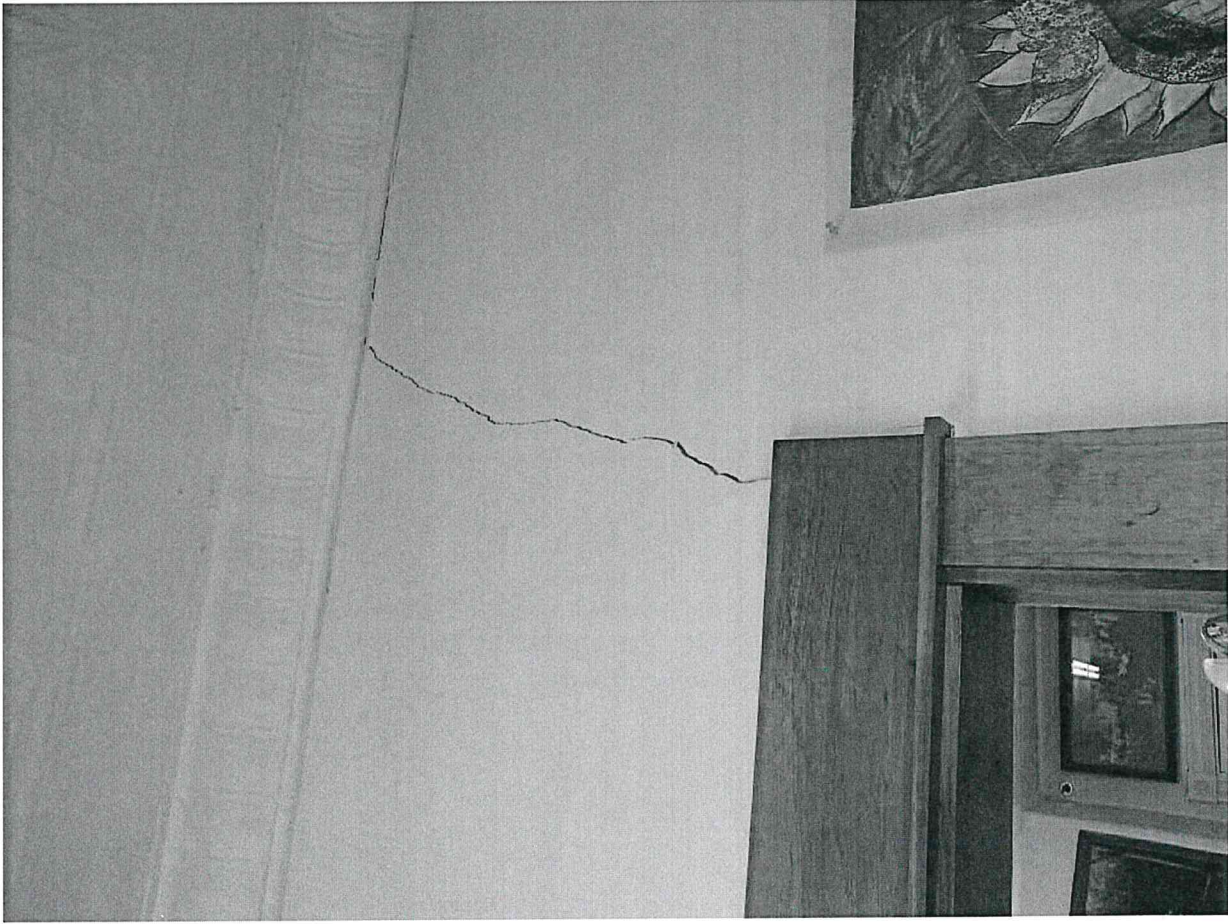
First Floor Wall Crack

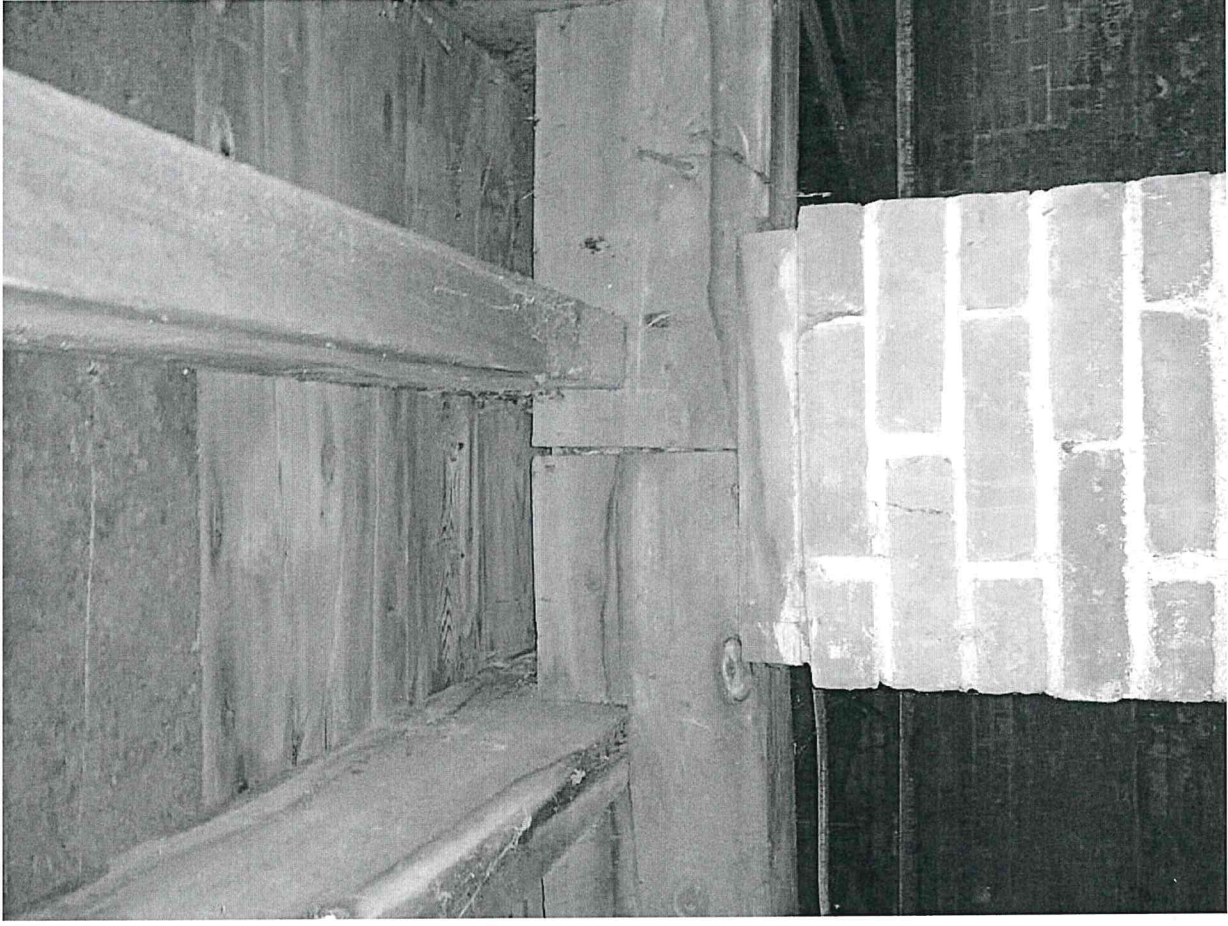
During the visit we also briefly looked at the structural framing located in the basement. The existing floor joists and beams supporting the joists have severe cracks along the members. The framing is a concern due to the age, condition, and lack of supports. The existing structural members have several structural defects. The existing floor joists have all been notched at the bottom of each floor joist. The floor joists bear the load onto ledgers and/or beams. The notching method creates stress concentrations in the middle of the floor joists. The stress concentration can cause the floor joists to split in the horizontal direction, which over time may cause the joists to fail.

Beam Crack

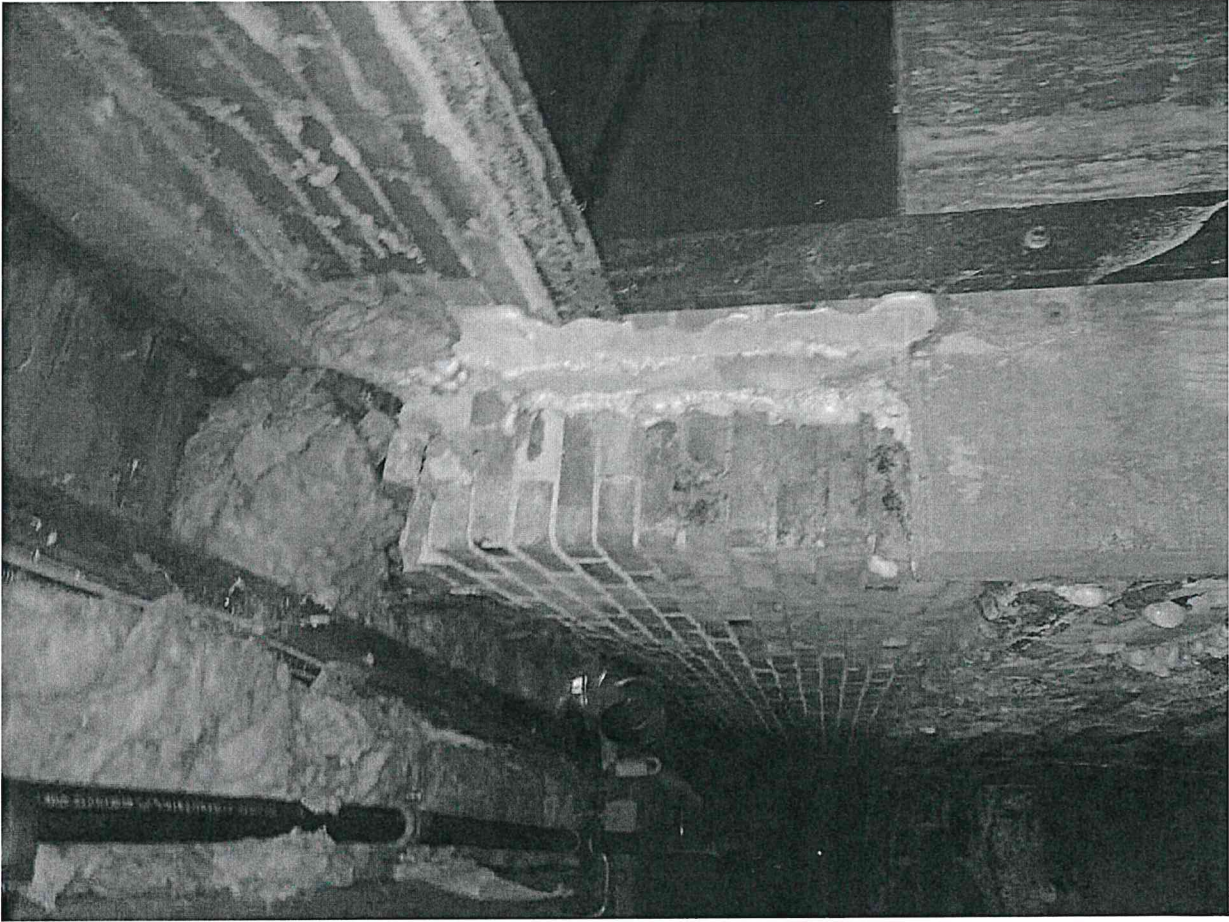
Due to insufficient drainage along the foundation, freeze/thaw cycling, and settlement of the original stone walls, the foundation walls have begun to buckle in several locations. The buckling is evident along each foundation wall. The brick foundation layer has several locations that are cracked, settled, and are bowing.

Foundation Wall

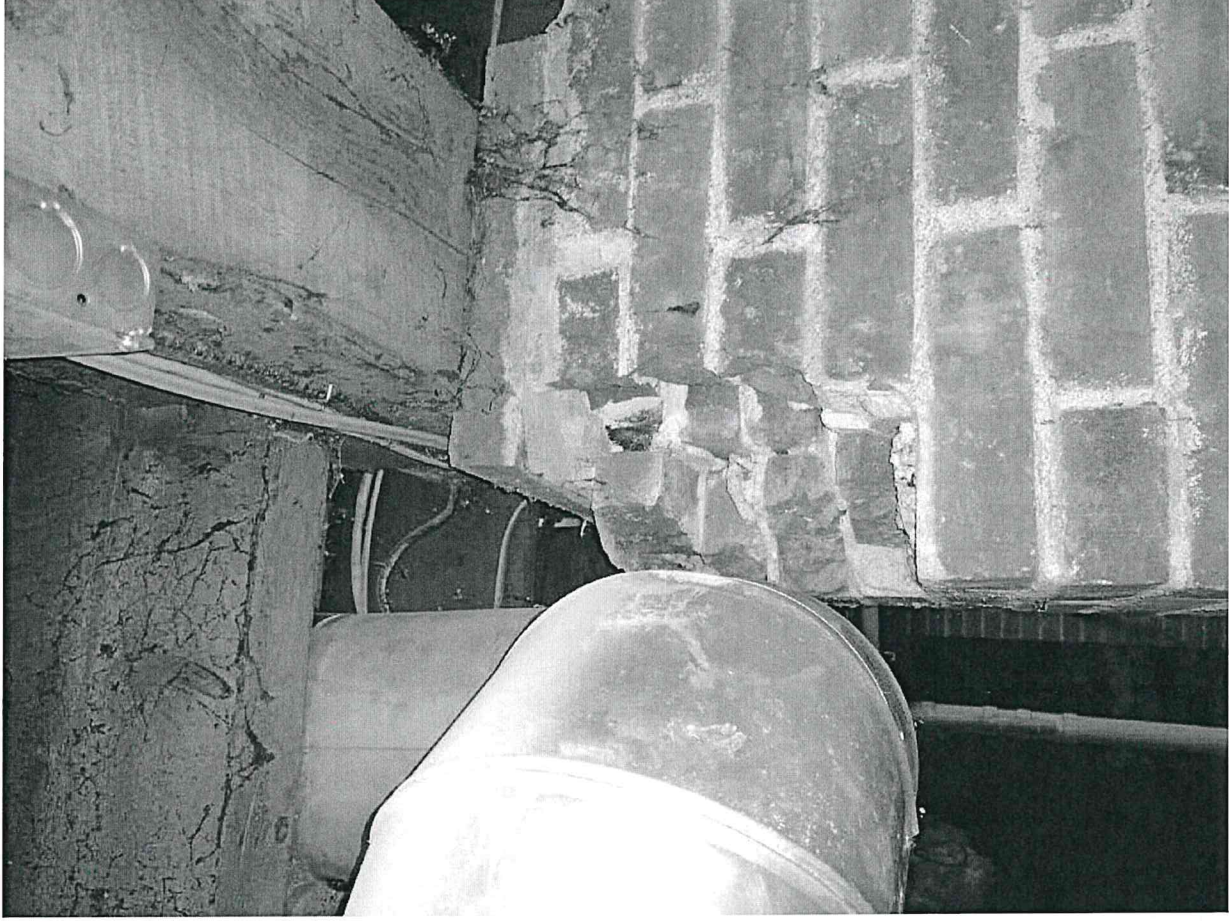
Damaged Column

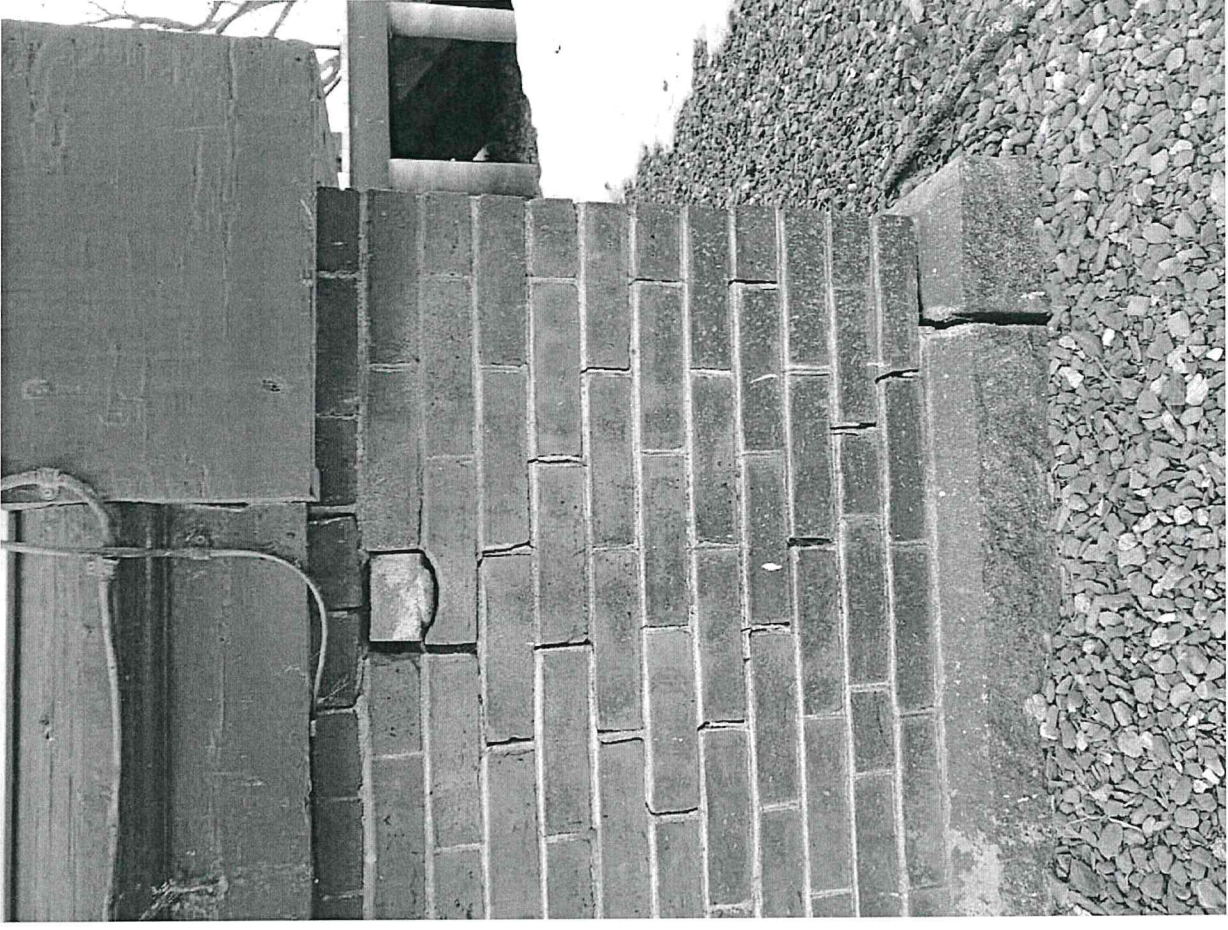
Cornerstone Crack

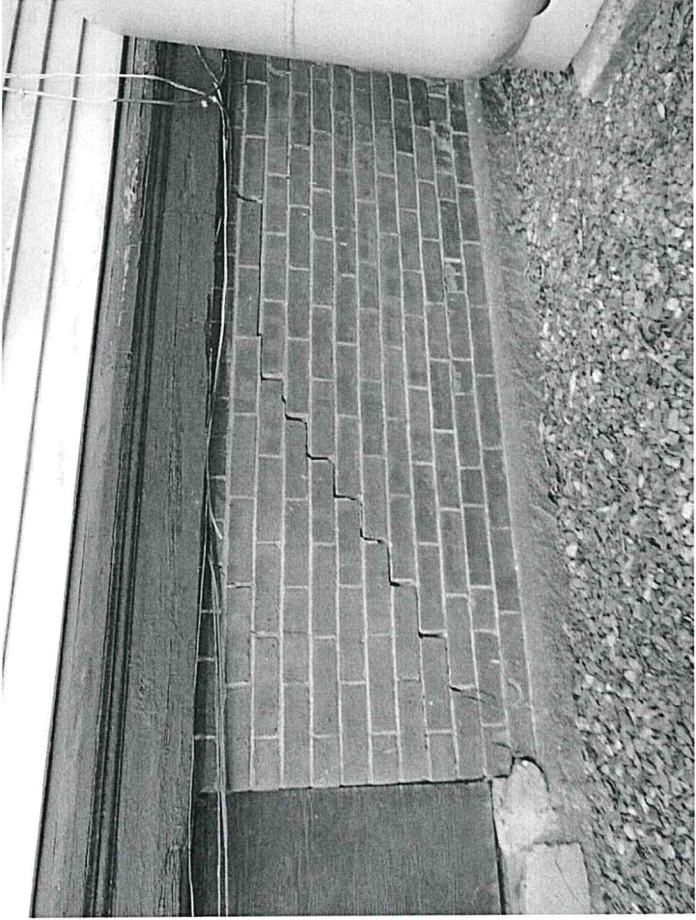
Foundation Crack

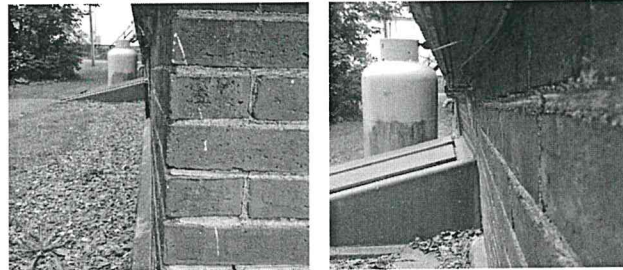
Notes: Bulkhead side wall has severe movement from top to bottom. Brick wall is bowing inward and near ground level and outward toward sill plates. Recommended a full engineering study.

Bulkhead side sweep in foundation wall. Recommend a qualified engineering company do a complete structural assessment of the building.

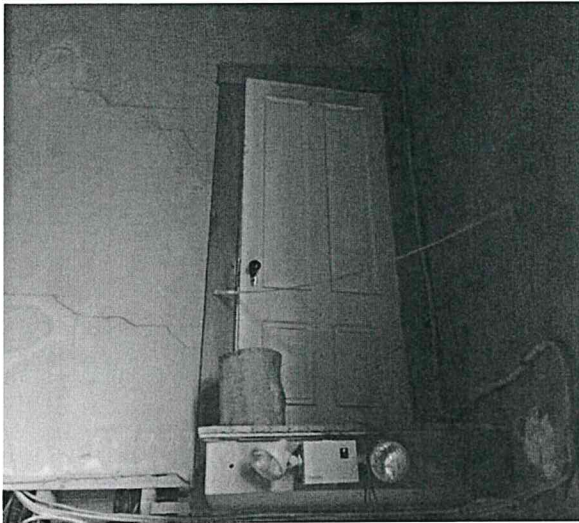
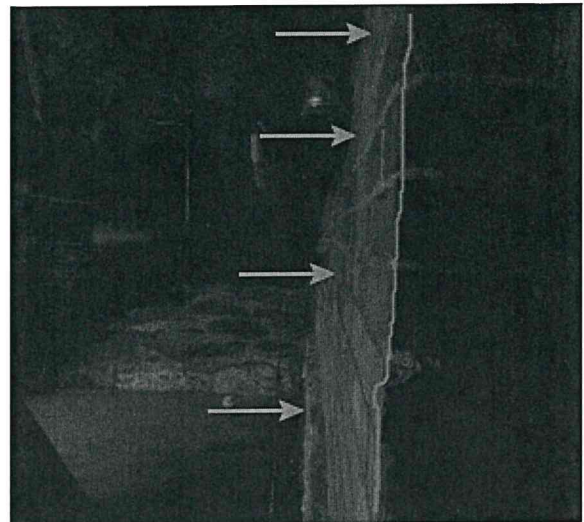
At bulkhead looking toward road, wall has evident movement. Recommend an engineer provide a structural assessment of the building and repaired.

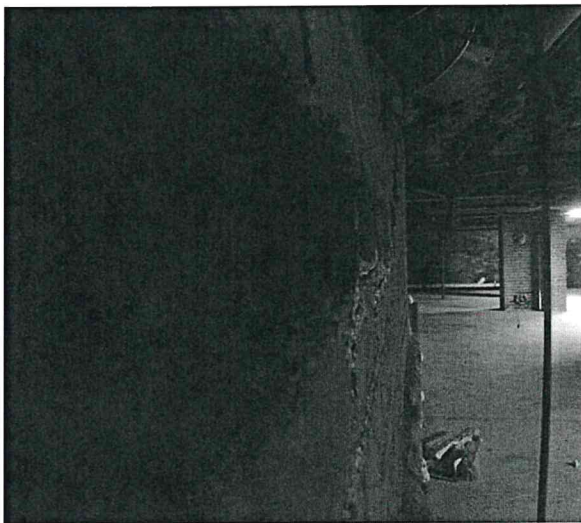
Basement wall bulkhead side
